Sample inspection

Sample report: made from the synthetic sample images that come with Thermal Report, not from a real inspection.

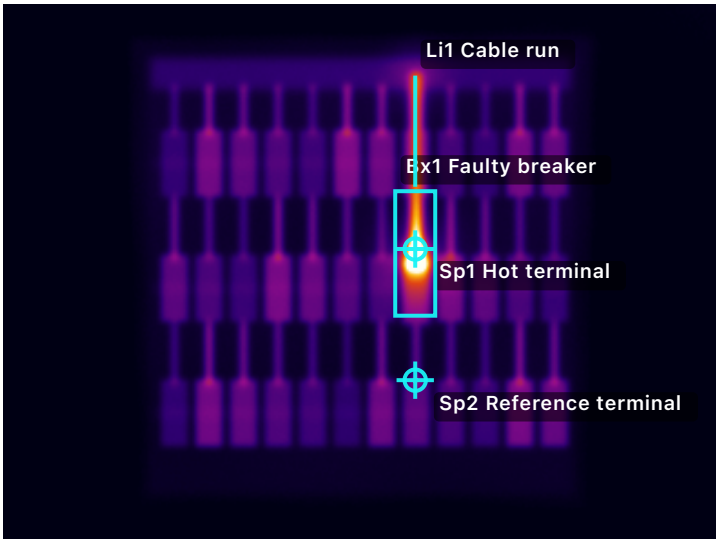
Section 1: Sample: Electrical panel

Severity: Urgent Action | Sample image

Delta Comparison (Max Temp): Sp1 Hot terminal vs Sp2 Reference terminal = +40.63 °C

Sample finding: the top terminal of breaker 8 in row 2 is about 40 °C hotter than the same terminal on similar breakers, which points to a loose or corroded connection. Have an electrician check and retighten it.

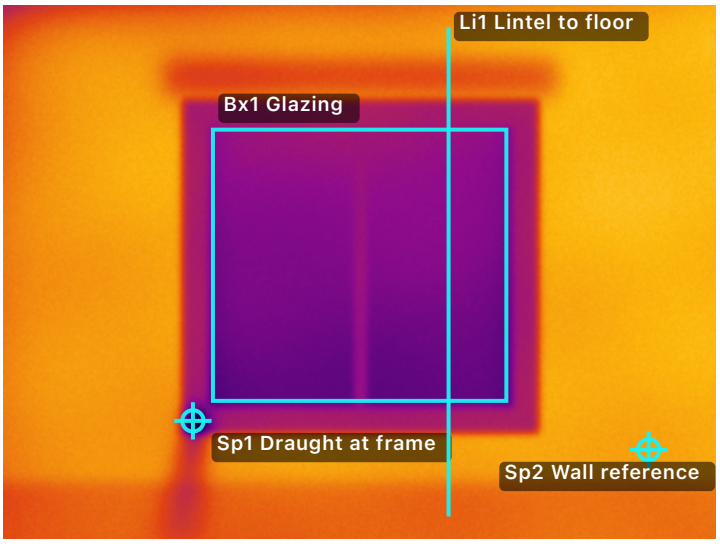
Section 2: Sample: Window heat loss

Severity: Repair Recommended | Sample image

Delta Comparison (Max Temp): Sp1 Draught at frame vs Sp2 Wall reference = -12.90 °C

Sample finding: cold air enters at the lower left corner of the window frame and runs down the wall. The lintel above the window is a thermal bridge. Reseal the frame joint.

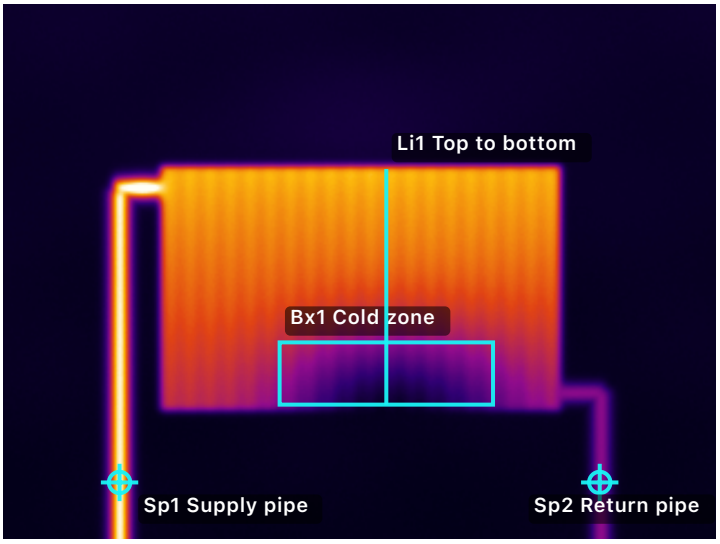
Section 3: Sample: Radiator

Severity: Monitor | Sample image

Delta Comparison (Max Temp): Sp1 Supply pipe vs Sp2 Return pipe = +24.57 °C

Sample finding: the lower middle of the radiator is about 20 °C colder than the top, a typical sign of sludge. Flush the radiator, then vent and balance the heating system.

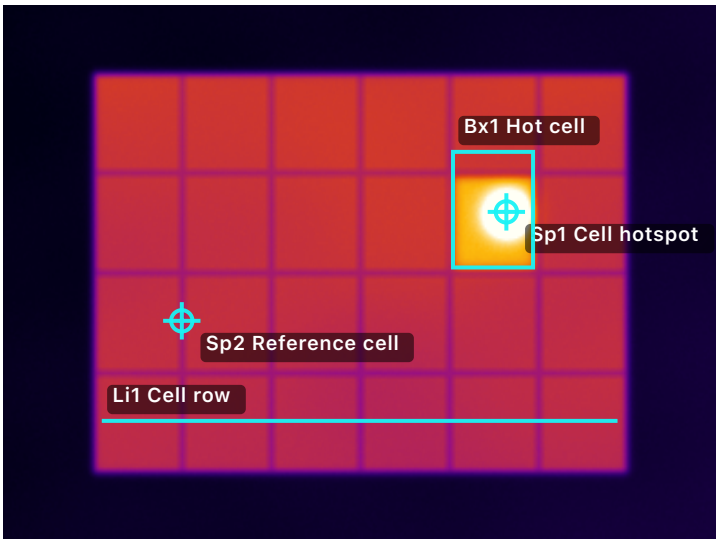
Section 4: Sample: Solar panel

Severity: Repair Recommended | Sample image

Delta Comparison (Max Temp): Sp1 Cell hotspot vs Sp2 Reference cell = +36.15 °C

Sample finding: one cell is much hotter than the cells around it (hotspot), which points to a cracked or shaded cell. Check the module and compare with the inverter data.
